Ductwork Roof Penetration Detail

Industrial Air Quality		IAQ
102 AG DRIVE Youngsville, NC 27596		
P# 919-562-7181 F# 919-562-7182		
Project: Paulo Products		
Drawing: Duct penetration		
Date: 5/8/09	Drawn by: RAV	
Sheet No:

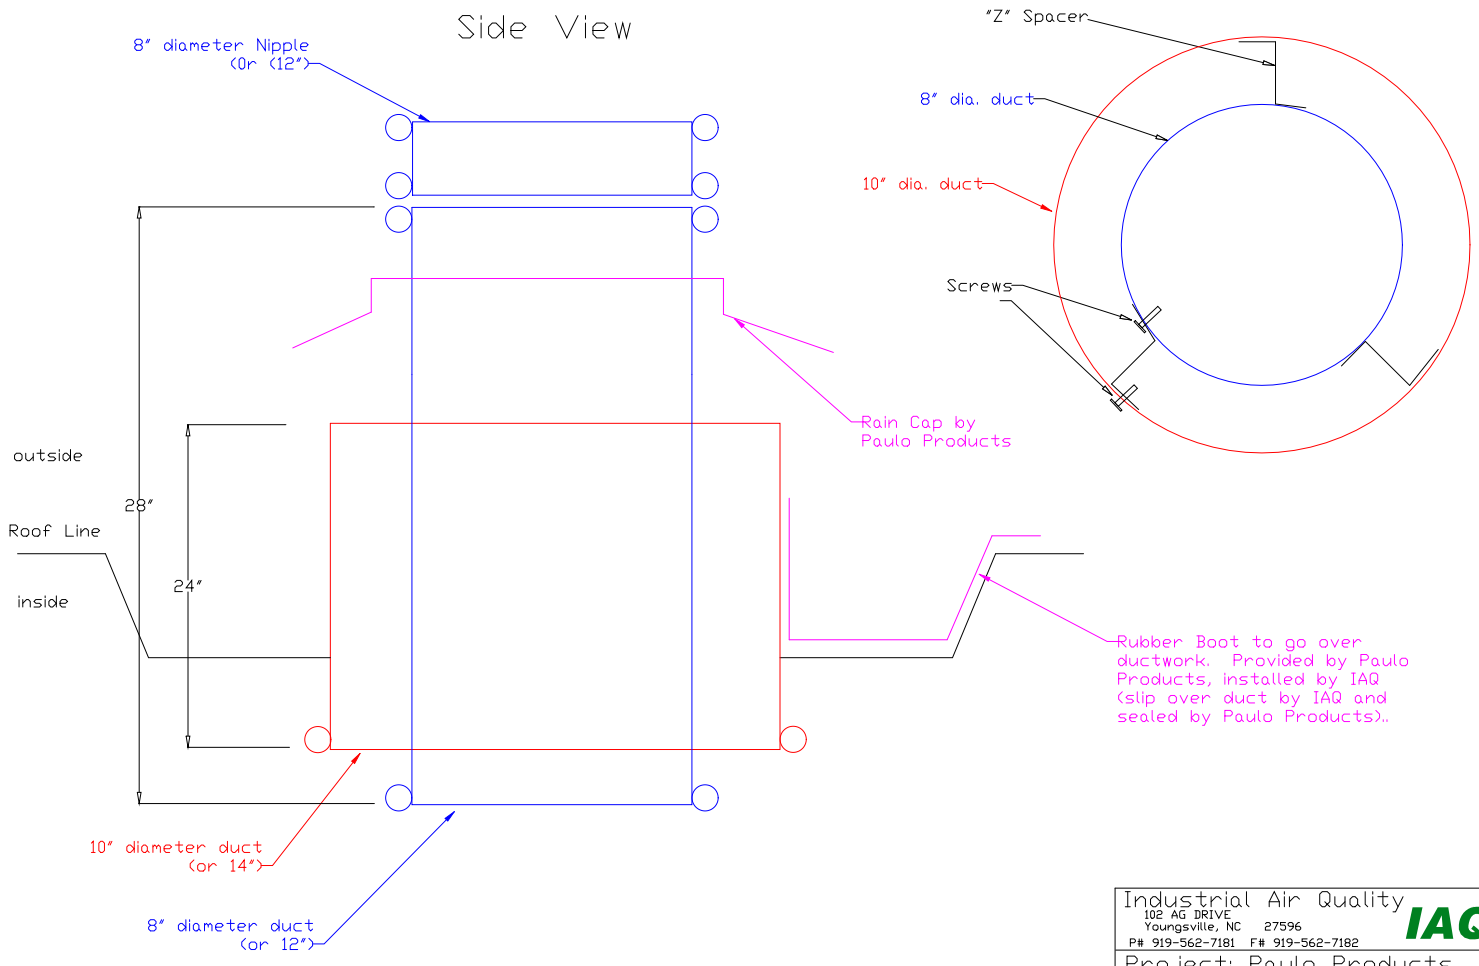
Side View

Plan View
