Trough Hood

Industrial Air Quality	
102 AG DRIVE Youngsville, NC 27596	
P# 919-562-7181 F# 919-562-7182	
Project: Danaher Tool	
Drawing: Trough Hood	
Date: 2/2/09	Drawn by: RAV
Sheet No:

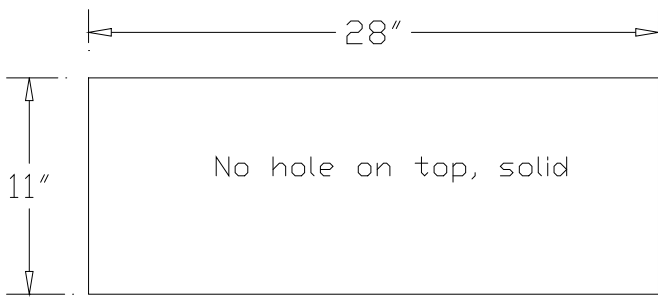
Plan View

Material: 20 Gauge Alum.

Pop Rivet all four corners and caulk

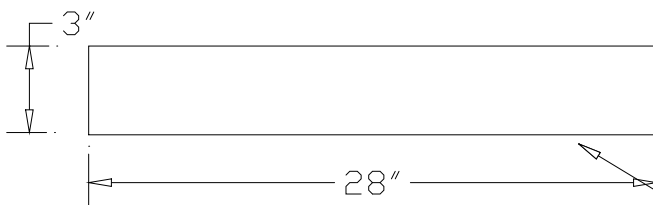
Side View

Leave bottom open
